City of Monte Sereno

As part of the 2019 Street Pavement Improvement Project several streets were Cape Sealed as a pavement maintenance treatment. Please see below for more information on what to expect in the next few weeks as the Cape Seal cures.

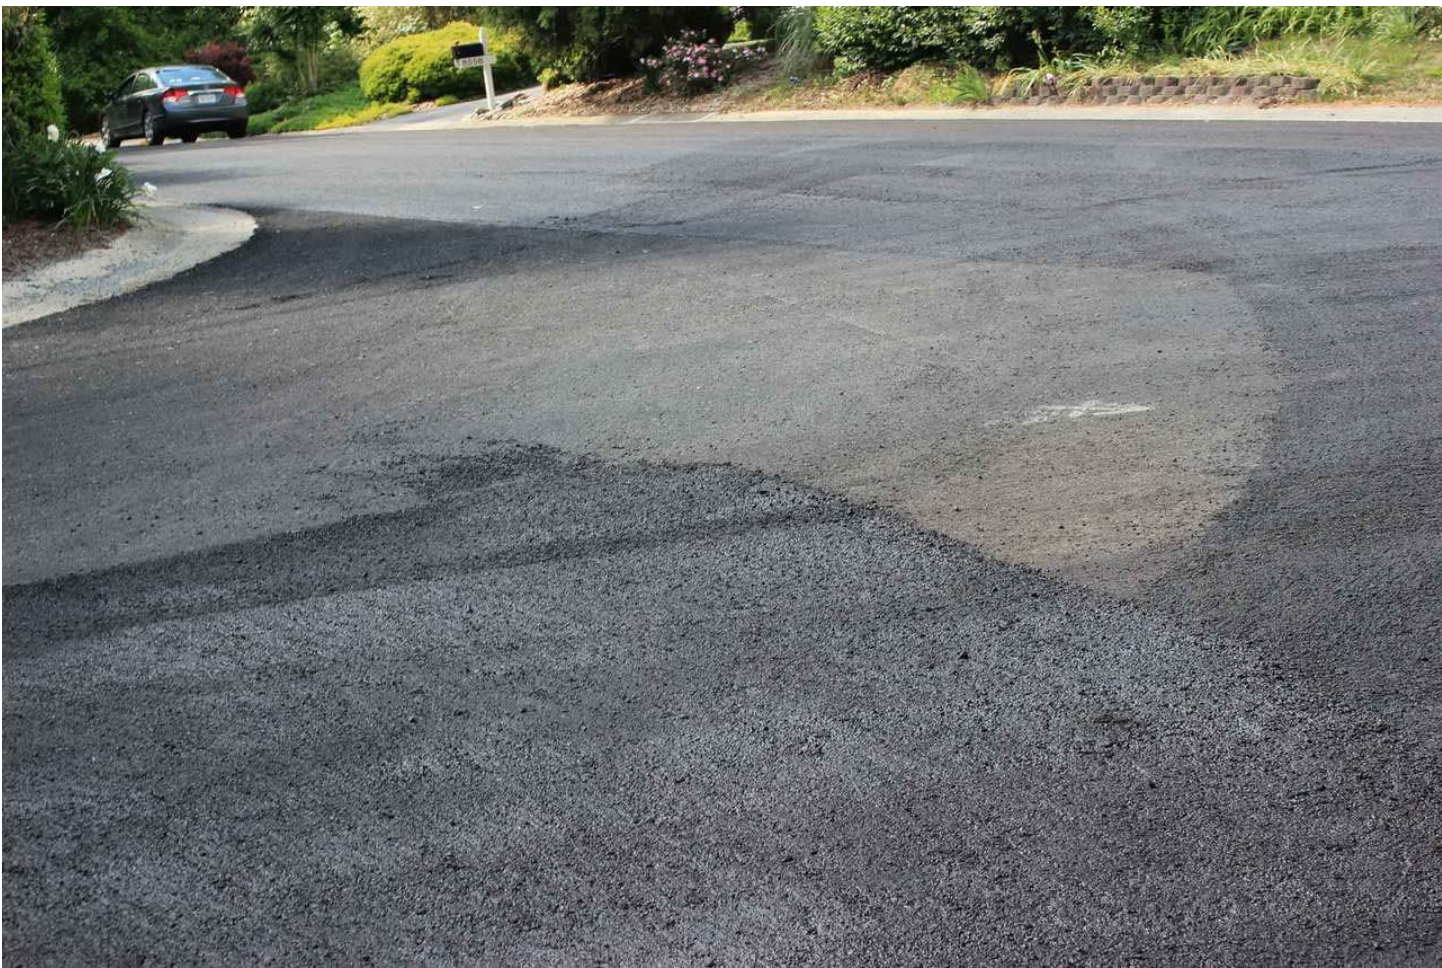
The photographs below are of the same area showing how slurry seal will "settle in". The first photo is the day after the slurry was installed. The second photo is the same area two months later.

For the first couple of weeks after the install, it's natural for some of the fine surface gravel to wear out of the slurry matrix. There may also be places along the gutter where loose aggregate can accumulate. After the slurry seal surface has had enough time to settle in, and the installation punch-list is completed, there is a final inspection. If there's too much material on the surface of the roads, a sweep will be completed to remove it.

It's also natural for the new surface to have some irregularities. These may include slight ridges, drag marks and/or color variations. These are due to the nature of the treatment's ingredients and the remnants of the installation process. In almost all cases, this is not bad work, but the nature of the treatment material and the best practices for installing it quickly and economically.
